## Case Study

# Cartiva Revision with BioPro® First MPJ Hemi

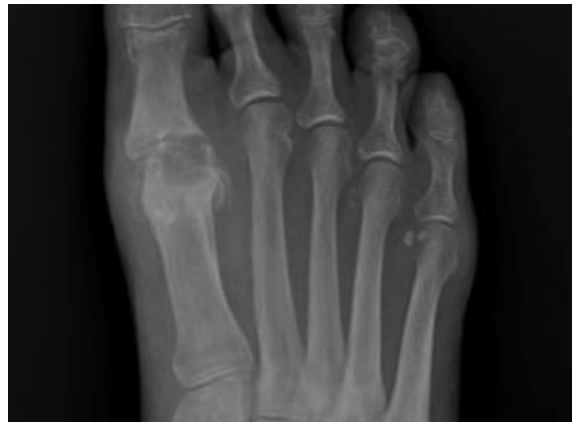
Radiographic examination revealed collapse of Cartiva implant, cystic changes can be seen; with severe asymmetrical narrowing of the joint. The patient was given the choice of first mpj arthrodesis or Hemiarthroplasty with the BioPro First MPJ Hemi.

The subluxed Cartiva implant was removed, the void was filled with bone graft and slight remodeling of the metatarsal head was performed. A small portion (4-5mm) of the proximal phalanx was resected to allow for implantation of a BioPro Porous Coated First MPJ Hemi Implant.

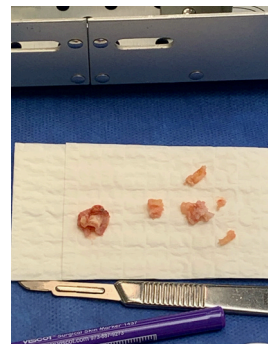
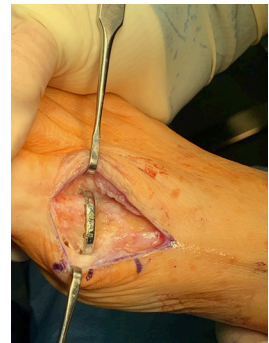
The patient had an uneventful post-op course and her pain was completely resolved. Range of motion was approximately 20 degrees dorsiflexion and 5 degrees plantarflexion with no pain. At 1-year post-op the patient is very happy and could ambulate without any difficulty.
