Technical Brief

Fifth Metatarsal Fracture Fixation with BioPro® Comprehensive Foot Plating System

Surgeon Author: Stephen A. Mariash, DPM

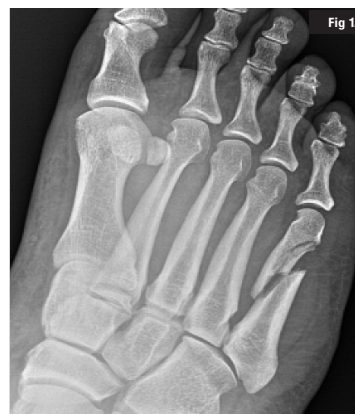
Fig 1A
Oblique radiograph demonstrating an unstable, displaced and mildly comminuted 5th metatarsal shaft fracture.

The patient fell down some stairs at home and described an inversion injury to the right foot. She was evaluated at the hospital emergency trauma center on the date of injury. Radiographs of the right foot demonstrated a mildly displaced fifth metatarsal shaft fracture. A splint was applied to the right lower extremity and the patient was not using crutches satisfactorily, therefore she was instructed to ambulate with a knee scooter, non-weight bearing on the right lower extremity and follow up with orthopedics on an outpatient basis. When she reported to my office, she presented with her brother-in-law as her guardian. He stated that the patient was not compliant with the non-weight-bearing instructions due to her mental disability. Repeat radiographs showed further displacement and instability (Fig. 1A and 1B).

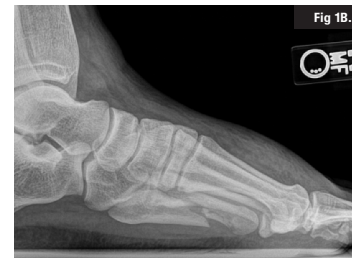
Fig 1B
Lateral radiograph demonstrating angulated 5th metatarsal shaft fracture.

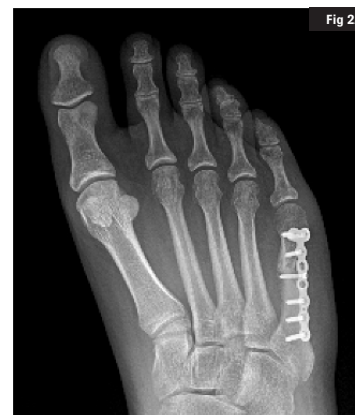
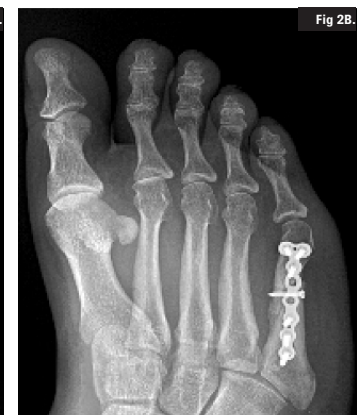
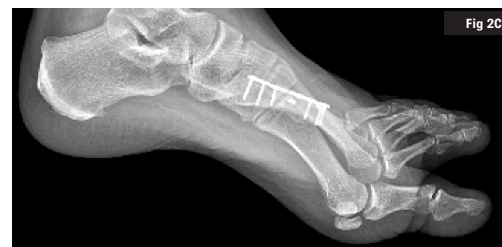
Fig 2A, 2B, 2C
Anteroposterior, oblique, and lateral radiographs demonstrating satisfactory alignment and osseous healing at 7 weeks post-op.

The patient had an uneventful post-op course. The CAM boot was continued at 4 weeks post-op with guarded weight-bearing. At 7 weeks post-op, the patient was pain free and radiographs showed satisfactory alignment with evidence of osseous healing (Fig. 2A, 2B, and 2C).
