Case Study

Cartiva Revision with BioPro® First MPJ Hemi

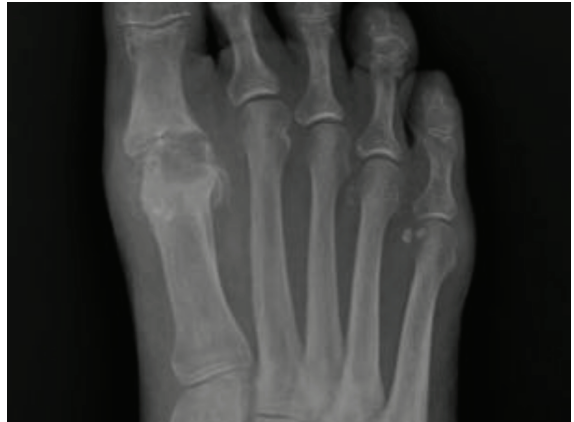
Radiographic examination revealed collapse of Cartiva implant, cystic changes can be seen; with severe asymmetrical narrowing of the joint. The patient was given the choice of first mpj arthrodesis or Hemiarthroplasty with the BioPro First MPJ Hemi.

The subluxed Cartiva implant was removed, the void was filled with bone graft and slight remodeling of the metatarsal head was performed. A small portion (4-5mm) of the proximal phalanx was resected to allow for implantation of a BioPro Porous Coated First MPJ Hemi Implant.

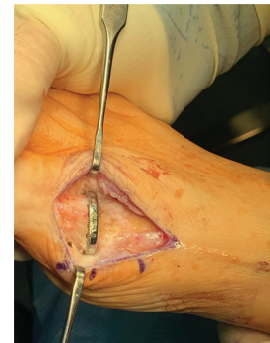
The patient had an uneventful post-op course and her pain was completely resolved. Range of motion was approximately 20 degrees dorsiflexion and 5 degrees plantarflexion with no pain. At 1-year post-op the patient is very happy and could ambulate without any difficulty.
